A Catastrophic Implant Failure after Total Knee Arthroplasty

Hamza Ozer¹, Mehmet Selçuk Şenol², Hasan Hüseyin Bozkurt³, Hakan Yusuf Selek¹, Ayşe Dursun⁴, Asim Ahmadov¹

¹Gazi University, Faculty of Medicine, Department of Orthopedics and Traumatology, Ankara, Türkiye

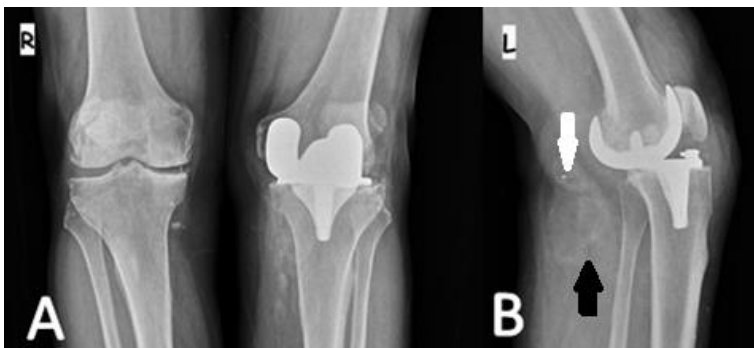
All laboratory tests, including serological tests for the detection of an infection, were negative. On plain X-rays, posterior cruciate insufficiency was detected via posterior dislocation of the knee. Signs of metallic debris, such as the “bubble sign” and “cloud sign”, were mostly demonstrated on the posterior aspect of the knee. Periprosthetic osteolysis was not diagnosed preoperatively. A tiny metallic particle was also observed at the deep popliteal part of the knee on X-rays (Fig. 1a and 1b).

Figure 1 – Preoperative X-Rays of the patient (A) showing metal-on-metal view of the components (B) showing anterior dislocation of the tibia; Black arrow showing “cloud sign” and the white arrow showing metallic particle at the deep popliteal part of the knee

Metallosis shows signs of failure on radiographic analysis. The “metal-line sign”, “cloud sign” and “bubble sign” are described as radiographically abnormal signs for suspected metallosis. These appearances on X-rays are suspected to be microscopic abrasion particles seated in the soft tissue around the knee. We were able to observe a “cloud sign” around the knee joint and a tiny metallic particle break from the tibial tray in the “cloud” (5).

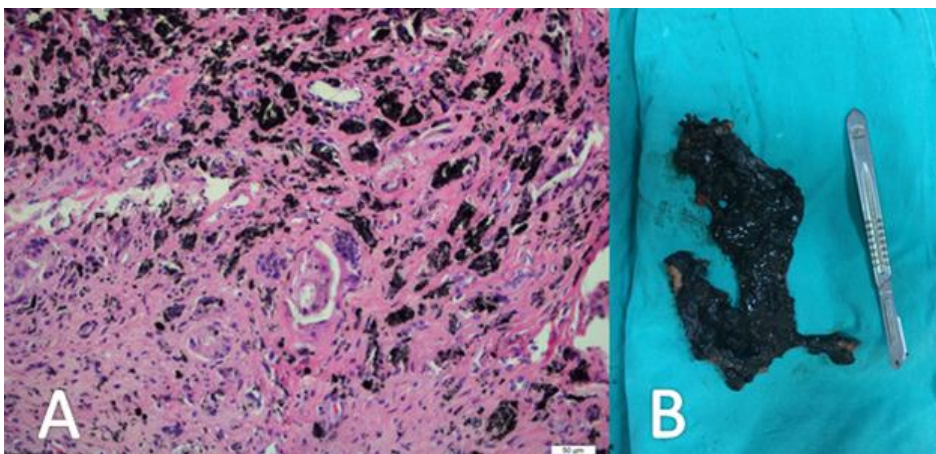
Histologic investigation of the debrided tissue showed inflammatory cells with fibrosis and foreign materials phagocytosed via multinucleated giant cells were diagnosed (hematoxylin-eosin stain × 10 magnification) (Fig. 2 A and B).

Figure 2 – (A) Microscopic view of the debrided tissue showed inflammatory cells with fibrosis and foreign materials (black) phagocytosed via multinucleated giant cells (hematoxylin-eosin stain × 10 magnification) (B) Excised black colored synovial tissue.

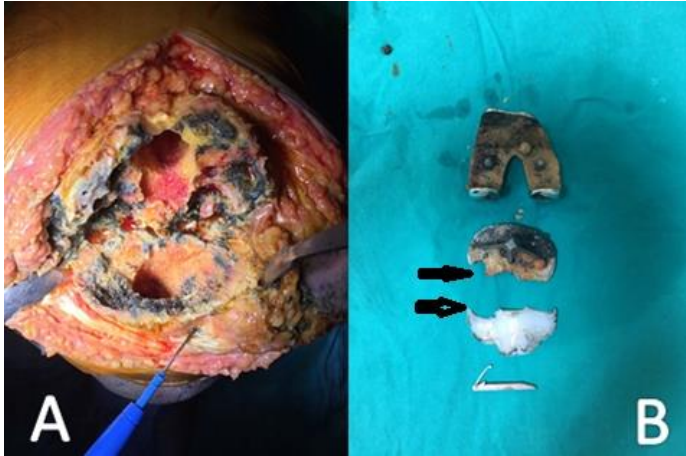
components were removed with ease. The posterior part of the polyethylene insert was destroyed, and the tibial metallic component beneath the insert was

eroded by the rolling force of the cobalt chromium femoral component (Fig. 3 A and B).

Figure 3 – (A) The cemented surface of the bones after removal of implants on both sides were filled with dark-colored material. Macroscopic osteolysis was observed in the cancellous parts of the distal femur and proximal tibia. The cortical bones were preserved on either side. (B) Removed implants; posterior part of the polyethylene insert was destroyed, and the tibial metallic component beneath the insert was eroded by the rolling force of the cobalt chromium femoral component.

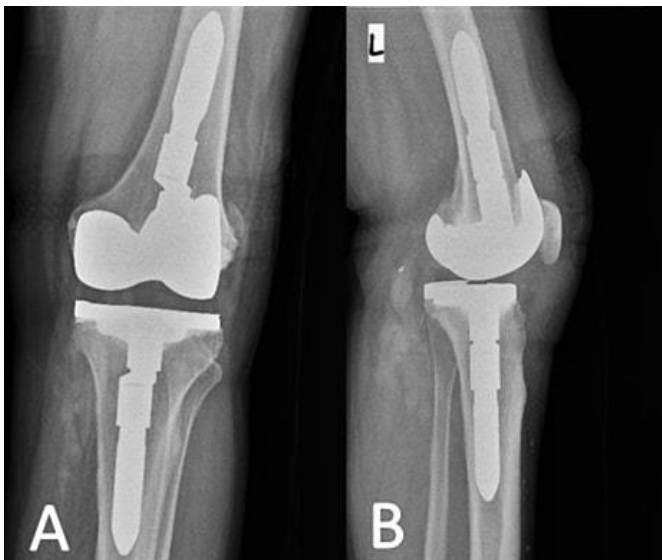
Figure 4 – Postoperative X-ray showing revised total knee prosthesis system (A) AP (B) Lateral view

The cemented surface of the bones on both sides were filled with dark-colored material. Macroscopic osteolysis was observed in the cancellous parts of the distal femur and proximal tibia. However, the cortical bones were preserved on either side. All the destructed osseous structures were debrided, and irrigation was performed with pulsatile lavage. A Legion Revision Knee System (Smith & Nephew, Memphis, TN, USA) was used to reconstruct the knee, while metallic augmentation blocks were used to reconstruct the defects on the femoral side, and cement was used for the same purpose on the tibial side (Fig. 4).
